Mink transport inspection (PL)

12.04.2018

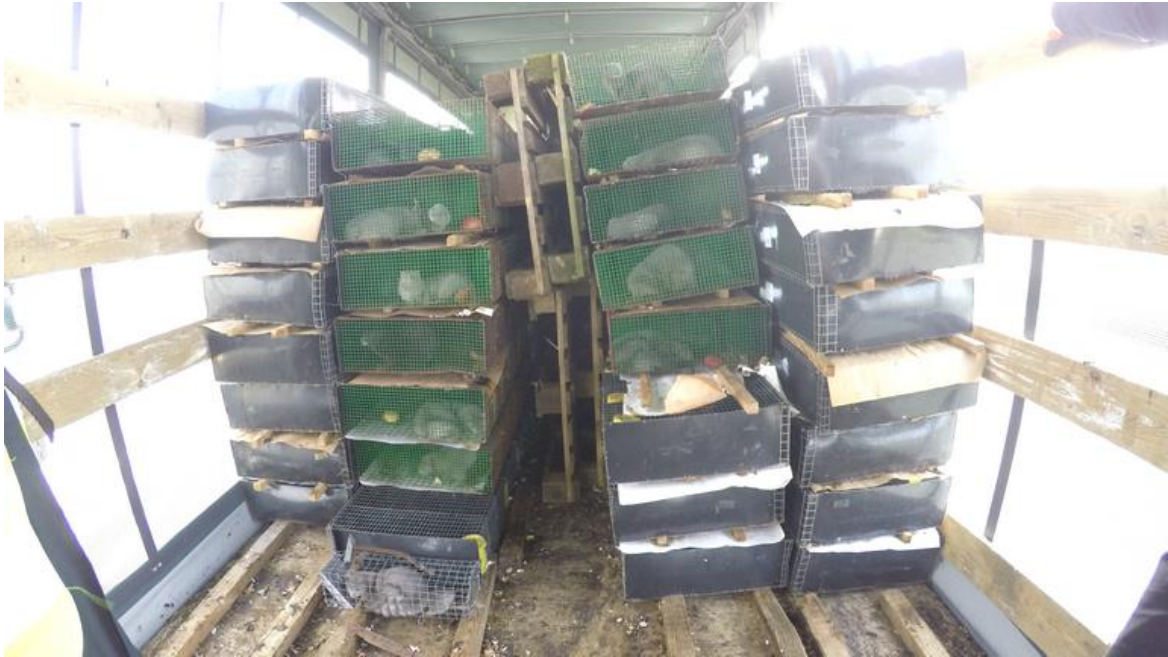
- Crates are arranged in 4 rows, 8 crates high in 3 rows, 7 crates high in 1 row. Between row 2 and 3, along the middle of the truck, pallets are stacked vertically (on their sides). On the floor of the vehicle, wooden bars are placed along its length, and bottom crates rest on them. Similar, but smaller wooden bars are placed between crates in each column. The bars are of different sizes and not secured with anything. As a result, crates (especially in one row) are placed unevenly, forcing animals to travel on a slanted/sloping floor. The crates are not secured with anything preventing the movement forward or backward. See Fig. 1.

- On sides, there are 3 wooden planks along the truck securing the crates, on the level of crate 4, 6 and 8 (counting from the bottom). The construction raises serious concerns as to its stability. See Fig. 1.
-

Figure 1: Arrangement of crates, cages in row 3 arranged at an angle, pallets blocking access, mink transported in an individual cage (in front of row 2), crates not secured.

- Due to arrangement of the crates, there is no access whatsoever to animals in rows 2 and 3, except minks that are at the back of the crates (looking from the front of the vehicle). See Fig. 1.
- Crates are made of metal mesh, some of them have sides secured with plastic. Between crates (horizontally) there are layers of thin paper/plastic or cardboard, probably to prevent contamination of minks from lower cages with excrements of minks from higher crates. The layers are sometimes bitten off or too small to prevent the leaking of excrements. They also do not provide comfort or support to the minks' feet. See Fig. 2.

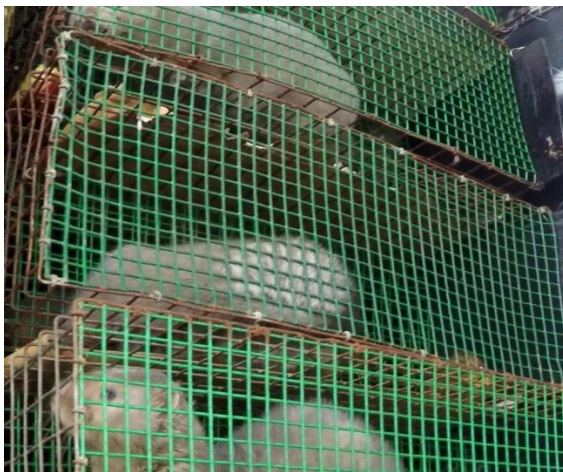
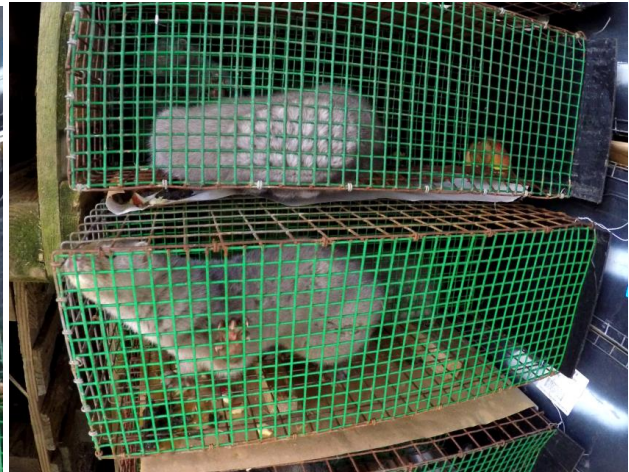
Figure 2: Metal mesh crates with paper in between

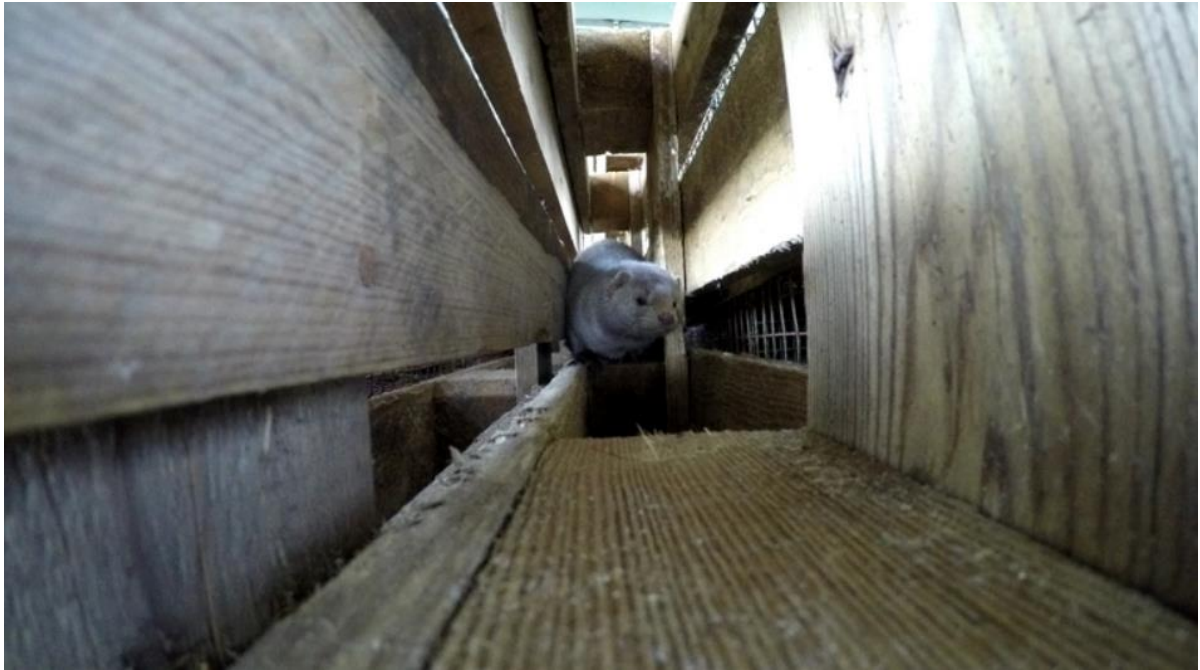
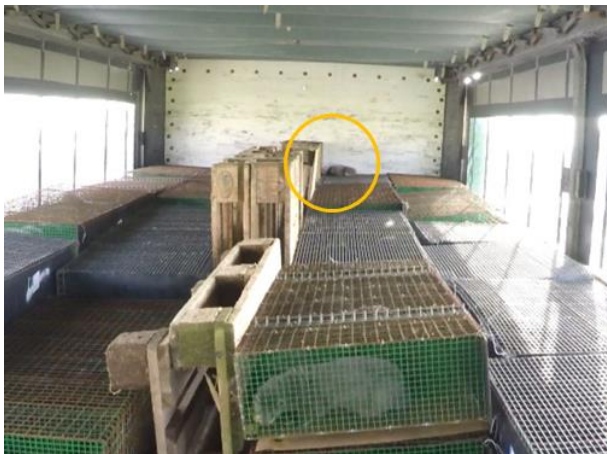
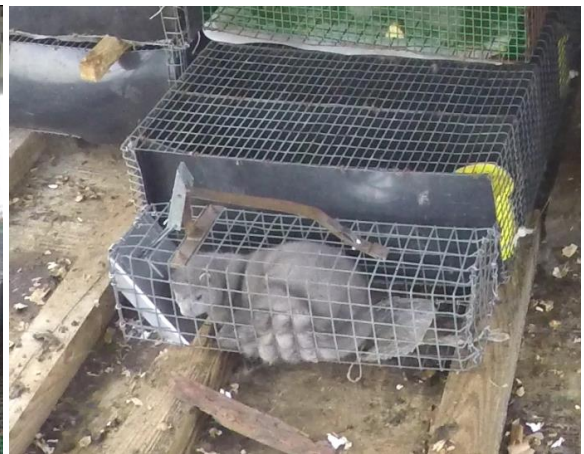
- One mink is found loose on pallets between rows 2 and 3. One is seen on top of row 3, behind the cabin. One mink is carried in a separate tiny crate the size of 1 compartment. The driver explains that it must have got loose and was caught in this extra crate. See Fig. 3.

Figure 3: Minks who escaped

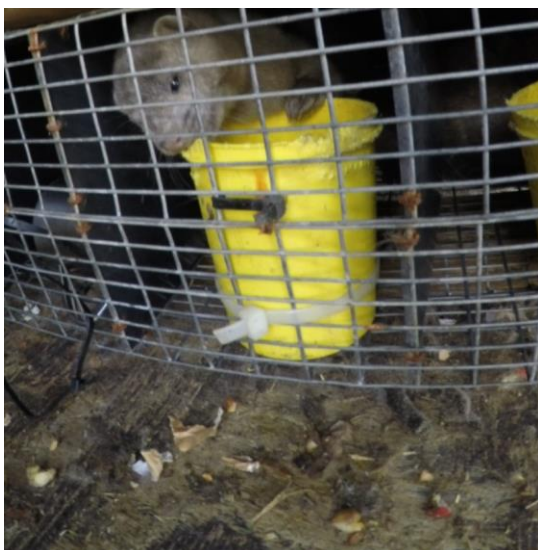
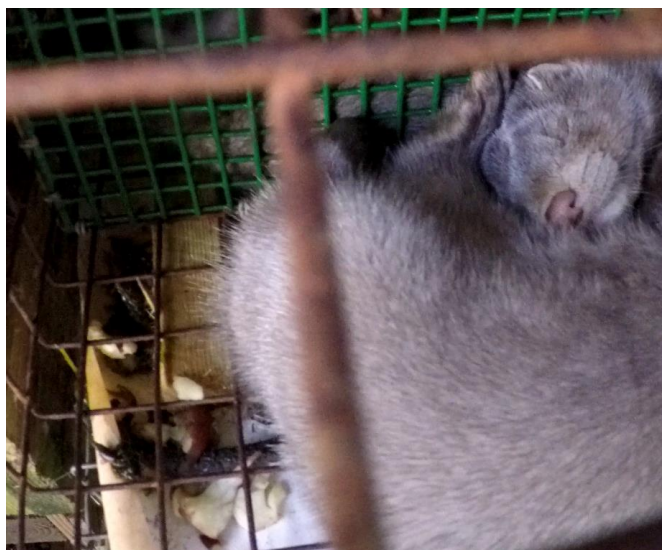
- The floor of the vehicle is dirty, there is a strong bad smell. The cages are dirty as well. See Fig. 4.

Figure 4: Dirty cages /floors

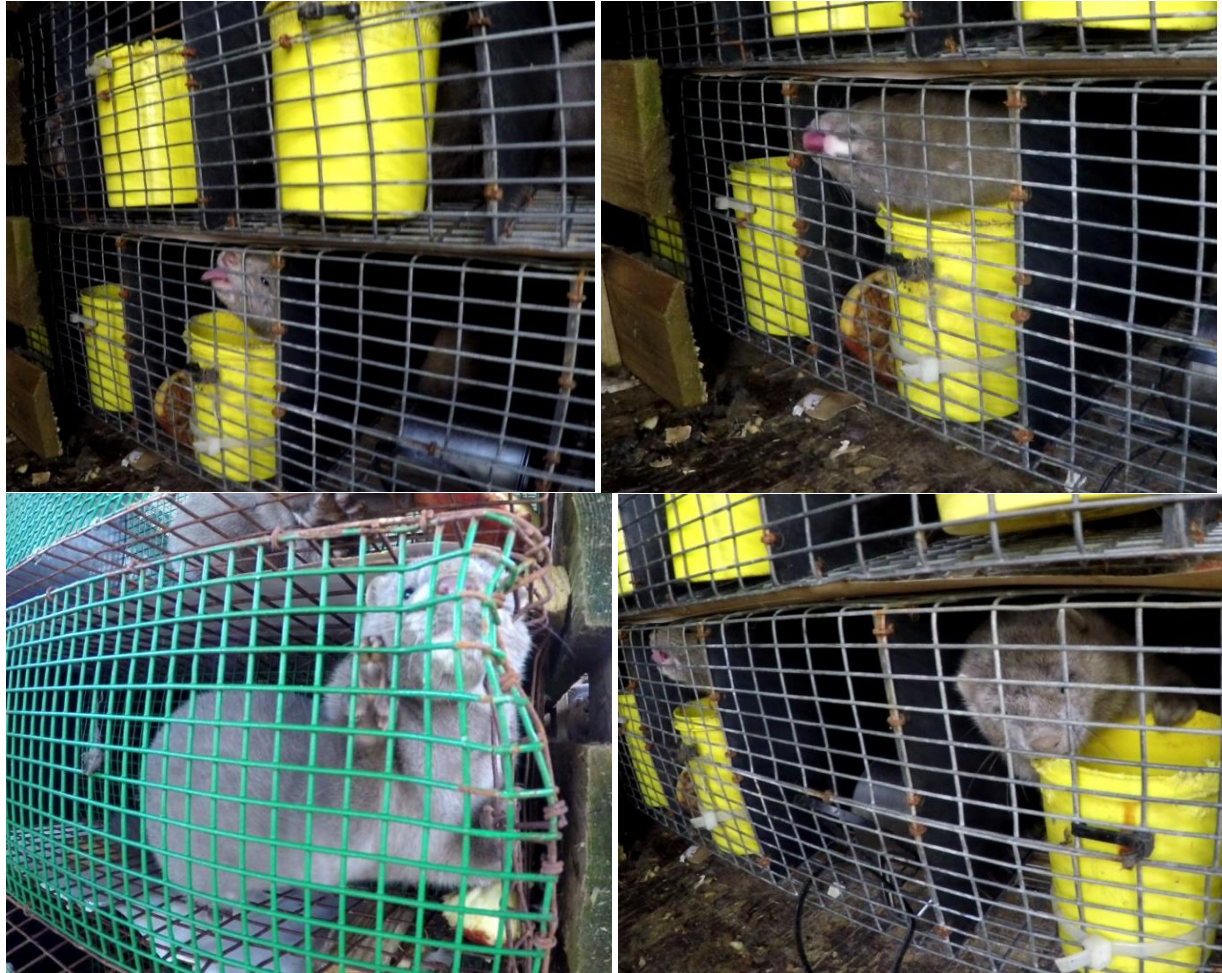
- Important note: several animals displayed severe stereotypies and stress signals, like rolling their tongues, biting in the food buckets, escape attempts and continuously walking back and forth (documented on video footage). See Fig. 5.

Figure 5: Minks displaying severe stereotypies and stress signals
