Mink transport inspection (PL)

12.04.2018

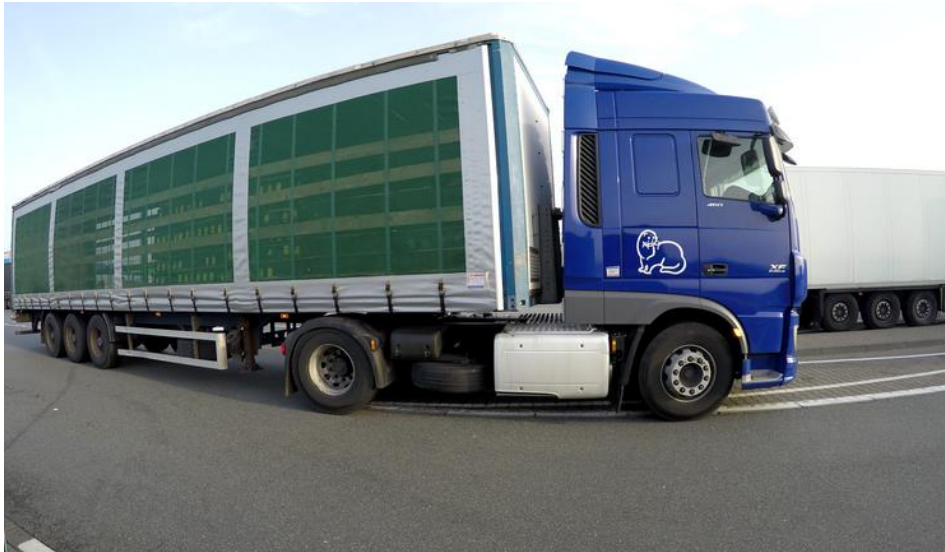
Figure 6. Futrex mink transport arriving at place of inspection

- Cabin: blue DAF, with white drawing of a mink on front and door, and name FUTREX in white under windscreen. See Fig. 6. The company owns several trucks, also used to transport feed, but all cabins are in the same colour and with the same logos.
- Semitrailer: green mesh curtains with silver lining (like for poultry), tailboard white with old Dutch inscriptions.
- Licence plates cabin: (PL) ZGL 44010
- Licence plates trailer: (PL) ZGL 90HP
- Approval certificate No. PL 32042812, limited to minks, valid until 10.06.2021
